# Manhole Inspection Summary

Manhole # S35S\_\_019MH

Insp Date: **1/28/08 4:20 PM**

**Location** Address: **1401 s.charles st**

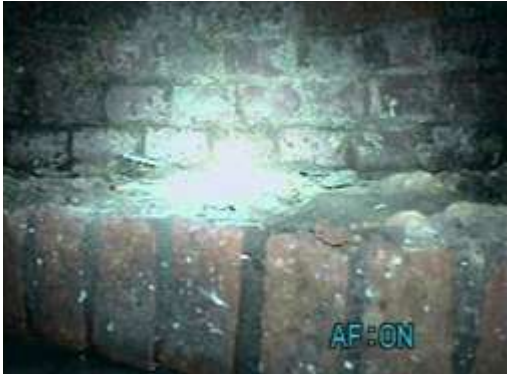
Misc

Condition: ☒ Sound ☐ Cracked ☐ Root Intrusion ☐ Deteriorated ☐ Leaks ☐ Debris

bench debris

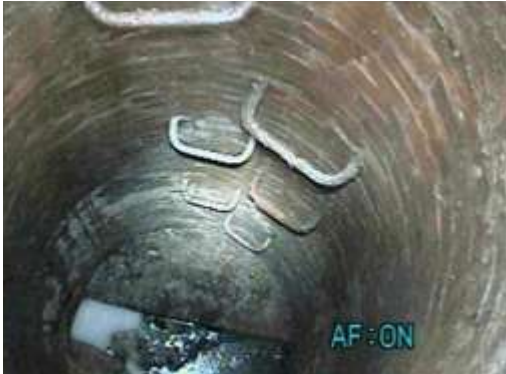
Defect 2

Count: **6** Missing: **0** ☒ **Corroded**

corroded steps

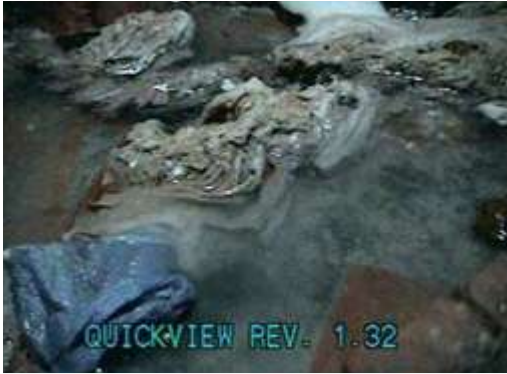
Defect 1

Condition: ☐ Sound ☐ Cracked ☐ Root Intrusion ☐ Deteriorated ☐ Leaks ☒ **Debris**

channel debris

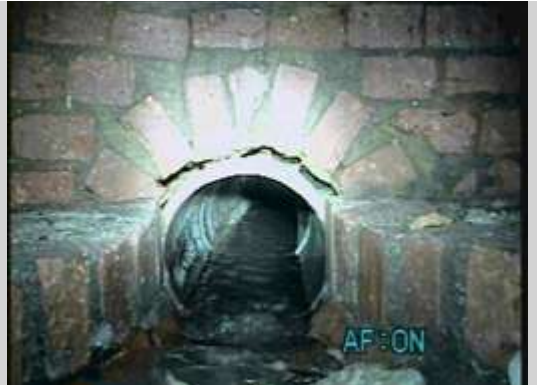
12 O'Clock Outflow

Invert Depth: 11.10 (ft.) Flow Characteristics: **Slow**

Deposits: ☐ None ☐ Mud ☐ Sludge ☒ **Debris** ☐ Grease

Silt Depth: 1 (in.) Deposits Extent: **Light**

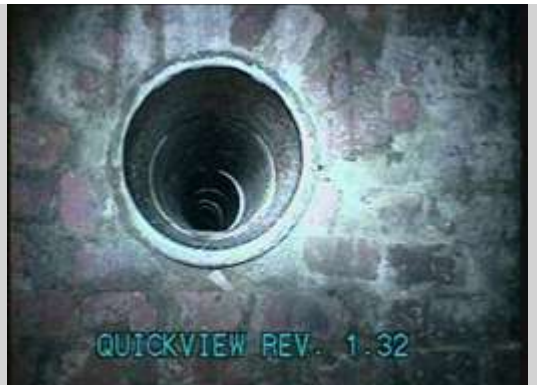
3 O'Clock Inflow

Invert Depth: 9.30 (ft.) Flow Characteristics: **None**

Deposits: ☒ **None** ☐ Mud ☐ Sludge ☐ Debris ☐ Grease

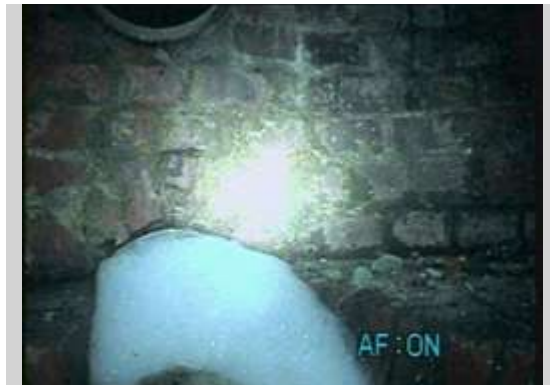
Drop In @ 3 O'Clock

Drop: **Outside Direct**

Drop Condition: **Open**

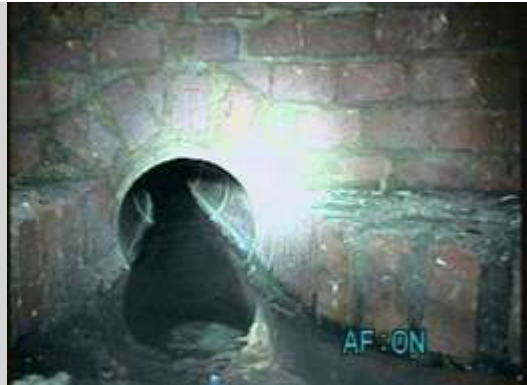
9 O'Clock Inflow

Invert Depth: 10.90 (ft.) Flow Characteristics: Slow

Deposits: ☒ None ☐ Mud ☐ Sludge ☐ Debris ☐ Grease
